TEST REPORT

FL45 COVER TEST

Client : Fibrelite Composites Ltd.

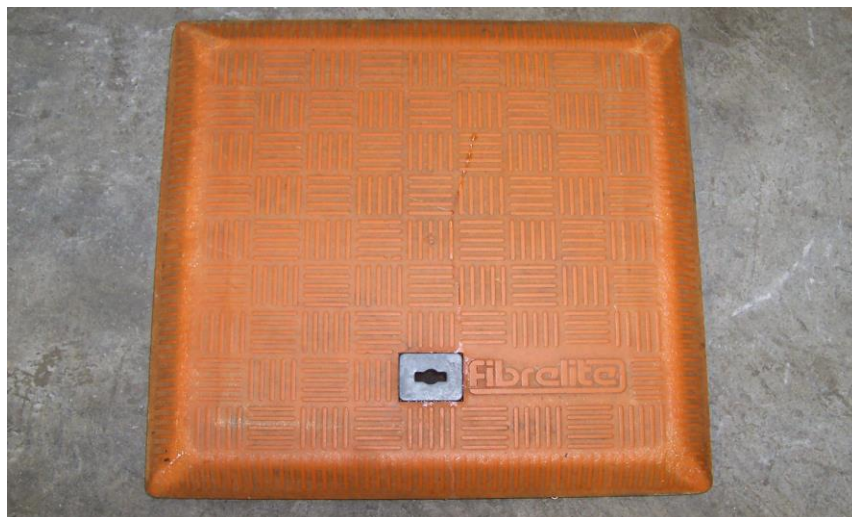
Photo. 1

The cover is an FL45, supplied by Fibrelite and manufactured in 1992 and has been in service ever since. It has slight wear on corners and edges but is in very good condition. It has no markings or serial number apart from the Fibrelite name on the top face. (Photo. 1)

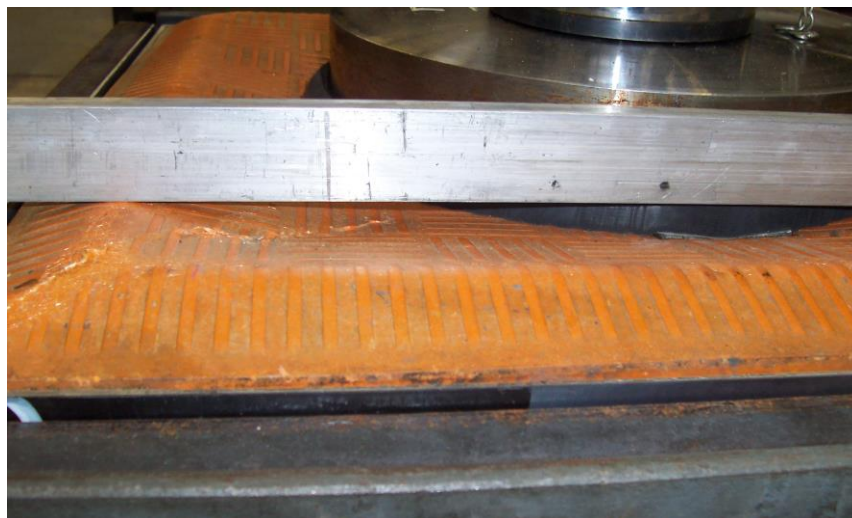
Photo. 4

The cover failed at 281kN. A loud bang was heard and the load could not be maintained.

On inspection of the cover a large depression had formed and a crack from one corner towards the centre. (Photo. 4)
