TEST REPORT

FL600 EN124 B125 Cover Test Test 2

Date: 13/03/12

Client: Fibrelite Composites Ltd.

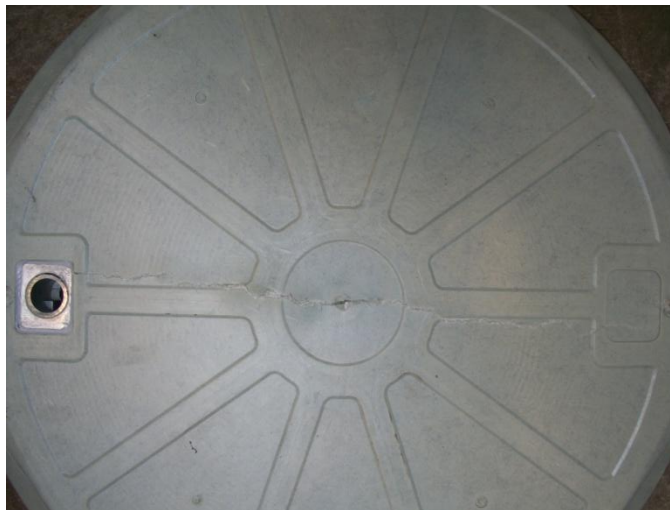
The cover was then loaded back up to failure.
Failure finally occurred at 152kN

On the underside there was a large crack running right across the cover. (Photo.3)

On the top face of the cover there were also a number of smaller cracks.
