TEST REPORT

FL900 EN124 C250 Cover Test

Date: 21/01/10

Client: Fibrelite Composites Ltd.

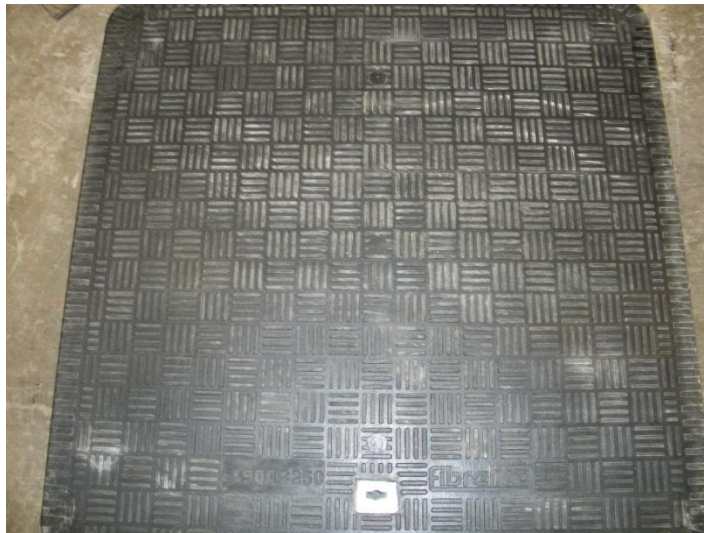
Photo.1

The cover supplied is a Fibrelite black FL900 with an overall size of 980mm x 980mm x 100mm. (Photo.1)

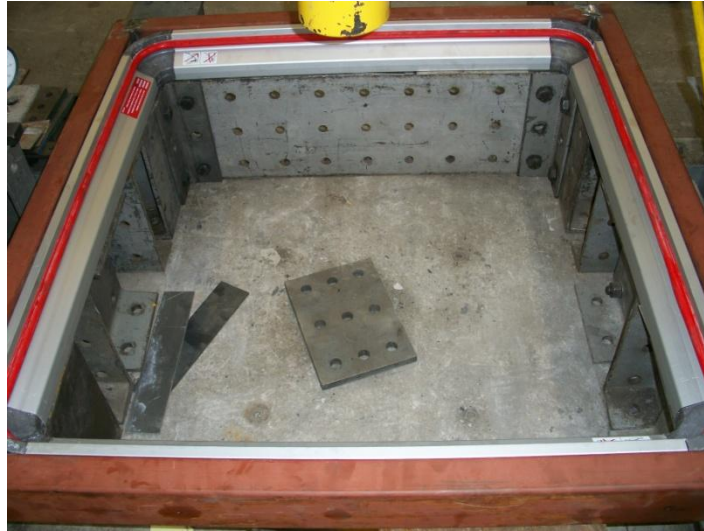
Photo.2

A steel box section frame was manufactured to support the cover's aluminium frame.
(See photo.2)

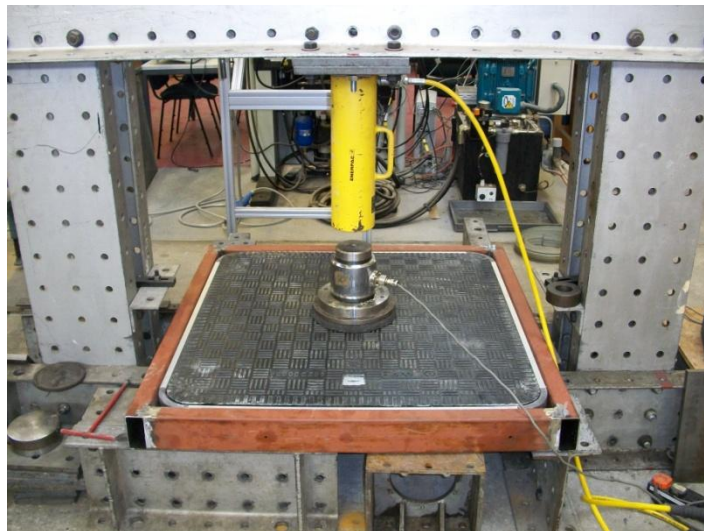
Photo.3

The test rig consists of a 'giant mecano' frame bolted to the floor and supporting the Enerpac 50 tonne hydraulic cylinder. The cover and frame was seated on steel channels and shimmed to level. (Photo 3)

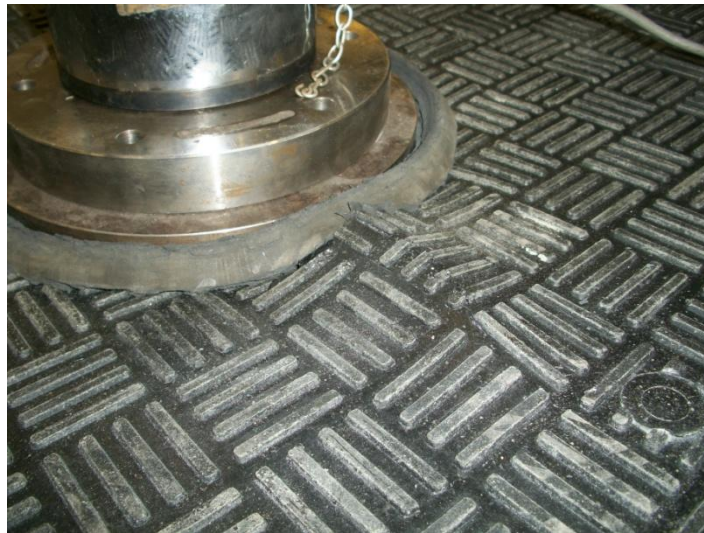
Photo.4

By 300kN the cracking noises were becoming louder and by 320kN the load had started to drop off. At 363kN the cover finally failed with it unable to hold anymore load and a large crack appearing on the top surface.

Photograph 4 shows the cover at failure and still under load.

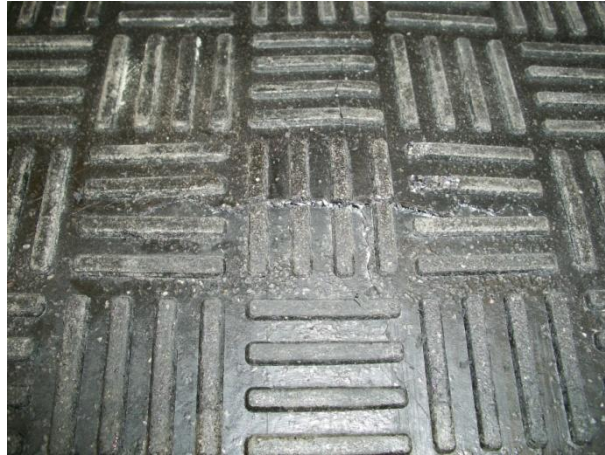
Photo.5

On the top surface a large crack had appeared and the cover was permanently dished around the loading area. (See photo.5)

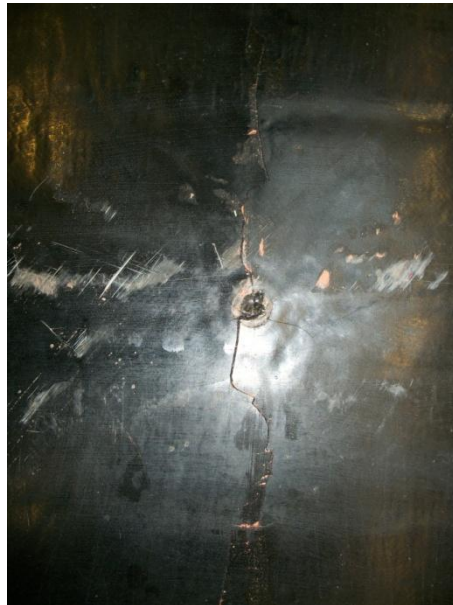
Photo.6

On the bottom surface there was a large crack running through the centre of the cover. (See photo.6)
