## **TEST REPORT**

### **FL900 EN124 E600 Cover Test**

Date: 16/04/13

**Client: Fibrelite Composites Ltd.**

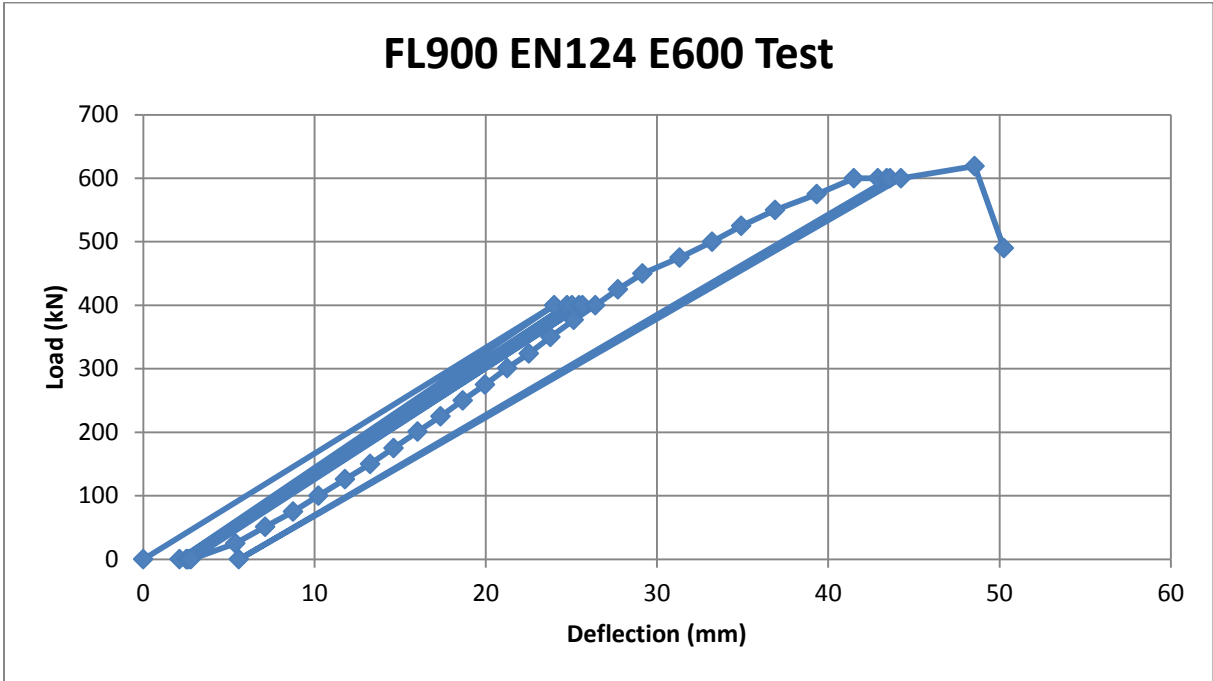
**FL900 EN124 E600 Test**

**The cover held the test load of 600kN for the required 30 seconds so therefore passed the EN124 E600 test.**

**In accordance with EN124 Clause 8.3.1 the permanent set of the cover was 2.78mm which is within the permissible stated in Table 8 of the standard. ( $1/300 \times 900 = 3.00\text{mm}$ ).**

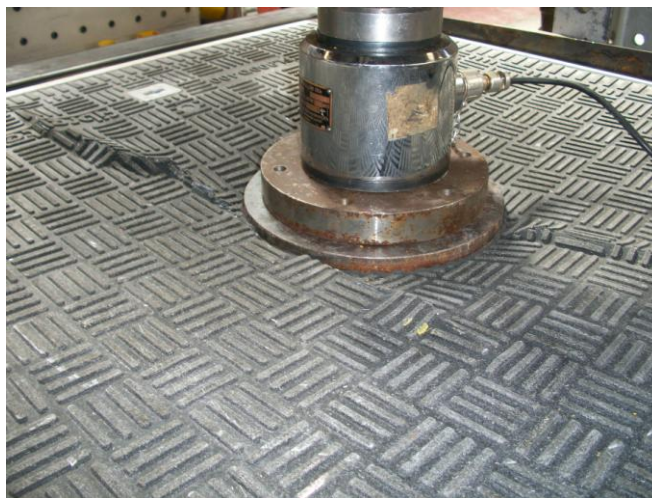
Photo.4

The cover finally failed at 619kN with some loud cracking noises and two large cracks appearing on the top face.

Photograph 4 shows the cover at failure and still under load.

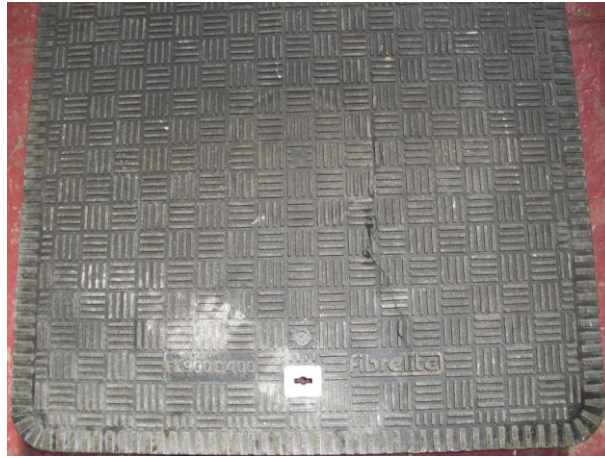
Photo.5

Photograph 5 shows the damage to the top face of the cover after failure.

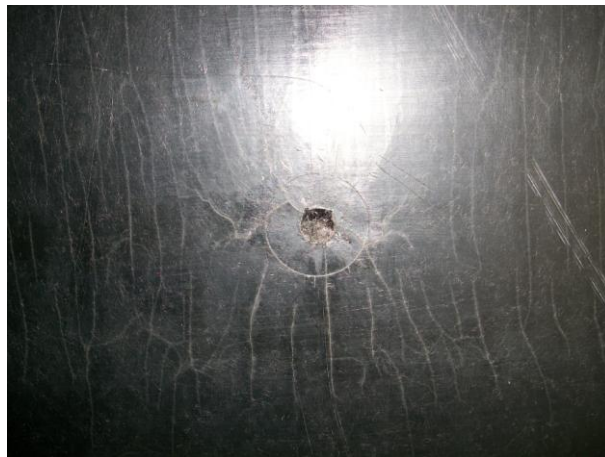
Photo.6

On the bottom surface there was some light cracking/crazing around the centre area of the cover. (See photo.6)
