TEST REPORT

FL90/CF/D400 Cover Test

Client: Fibrelite Composites Ltd.

Date: 07/04/06

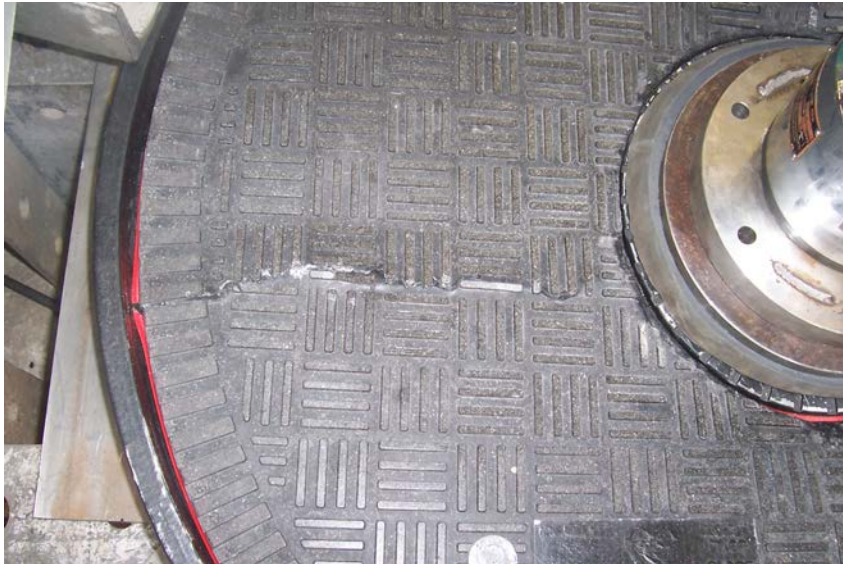
Photo.3

After the initial test load was achieved the cover was loaded further and at 445kN the cover failed.

On inspection two cracks had appeared on the top surface and the frame had bulged out slightly leaving a gap between cover and frame. (See photo.3)

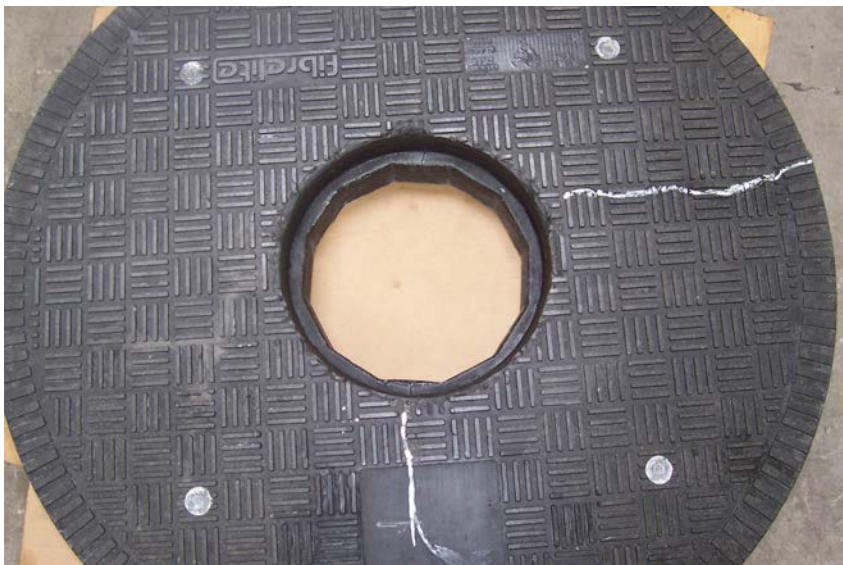
Photo.4

Photograph 4 shows both cracks on top face after removal of cover from test rig.

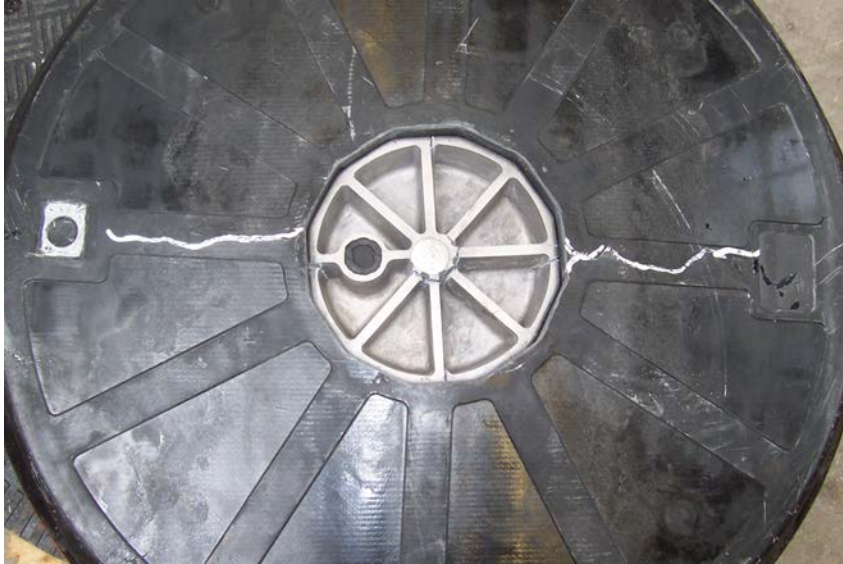
Photo.5

Photograph 5 shows cracking to underside of the cover after removal from test rig.

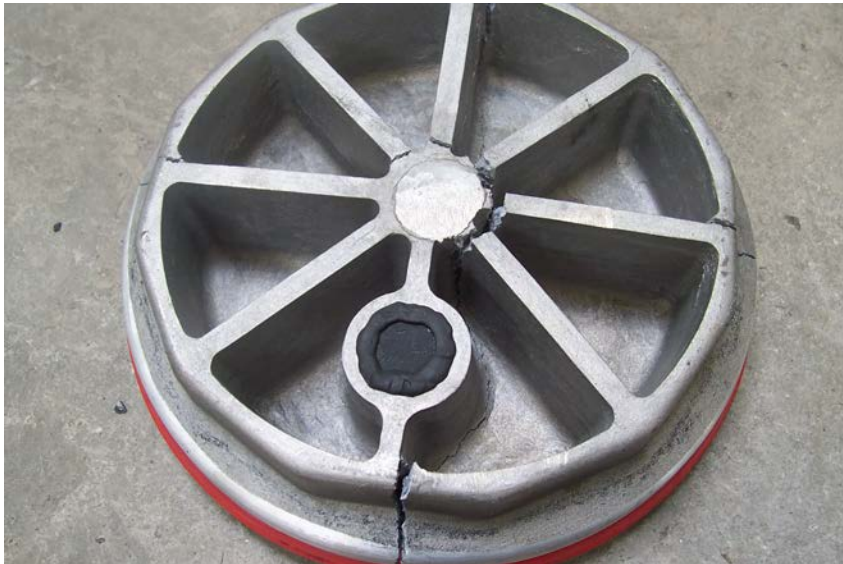
Photo.6

The aluminium port cover showed cracking to top face and serious cracking to webs on the underside. (Photo.6)
