TEST REPORT

FL90 Cover Test

Date: 28/05/10

Client: Fibrelite Composites Ltd.

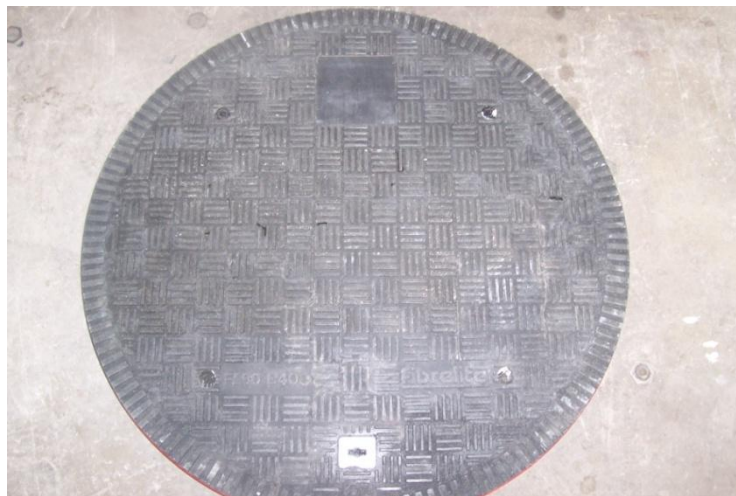
Photo. 1

The cover supplied is an FL90 and of composite construction. (See photo. 1)
No. on edge of cover – 104470

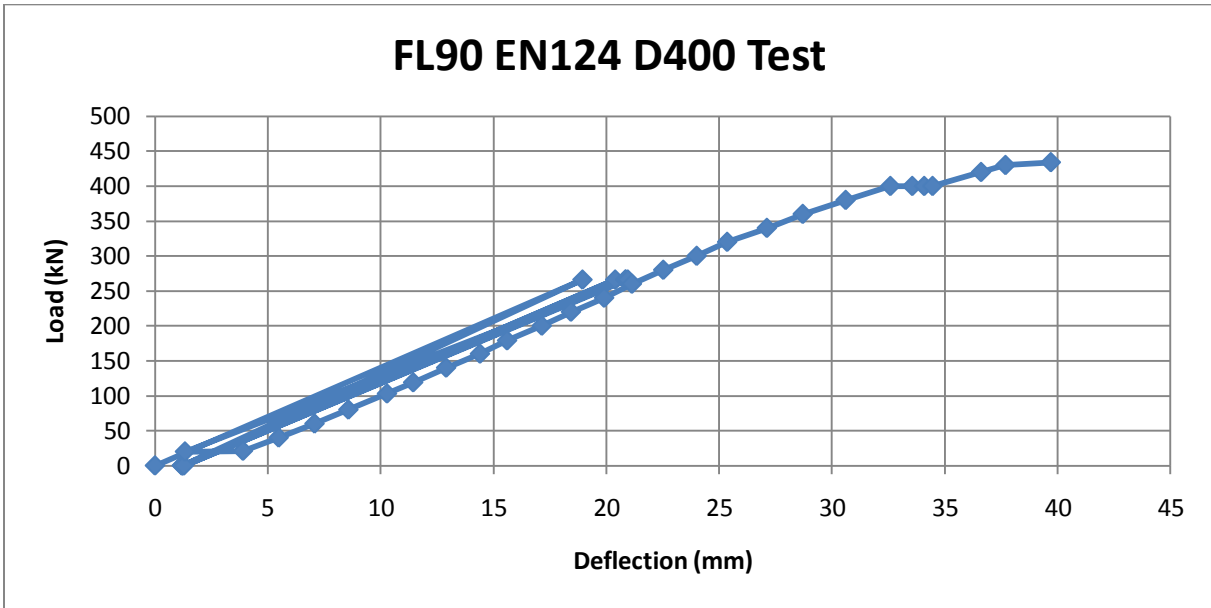
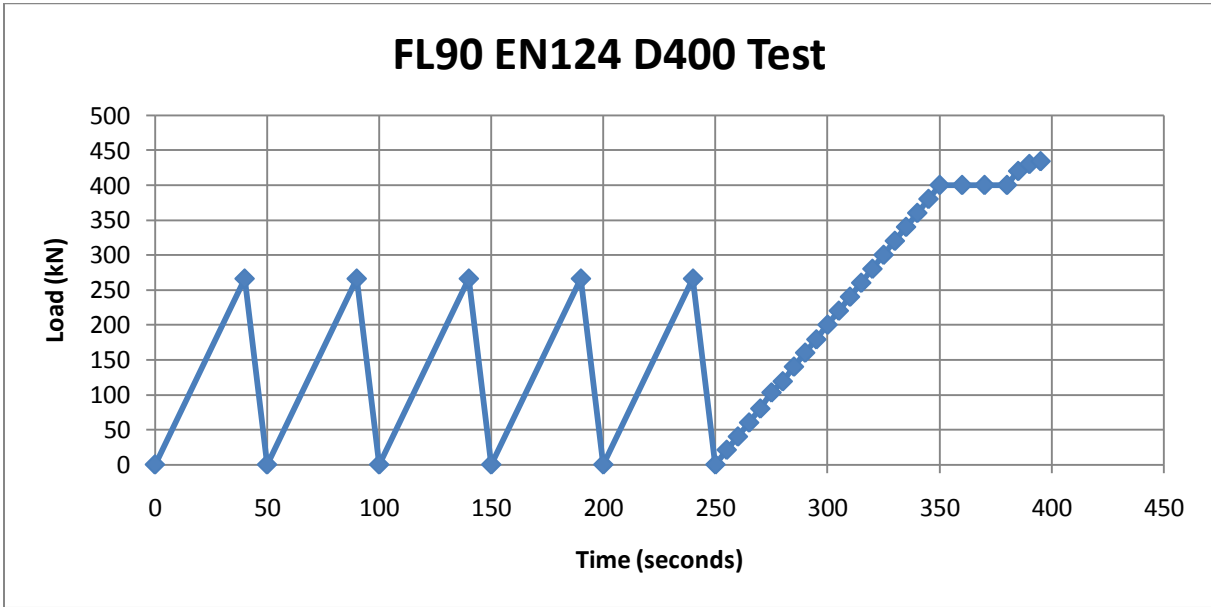
In accordance with EN124 Clause 8.3.1 the permanent set of the cover was 1.33mm which is within the permissible stated in Table 8 of the standard. ($1/300 \times 900 = 3.0\text{mm}$).

The cover held the test load of 400kN for the required 30 seconds with no visible signs of any cracking and therefore passed the test.

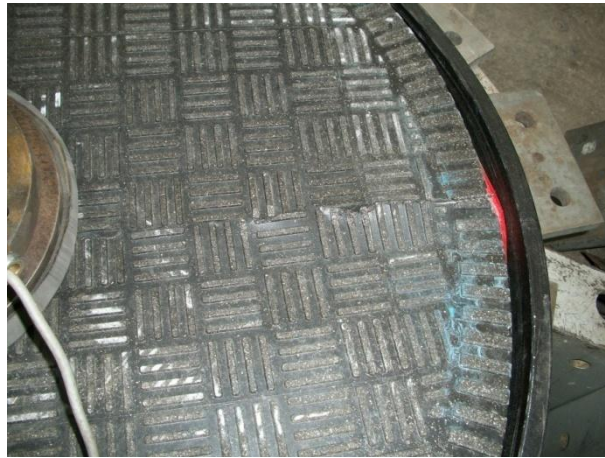
Photo.3

The cover finally failed at 434kN with a loud bang and a large crack appearing on the top surface. Photograph 3 shows the cover still in the test rig after failure.

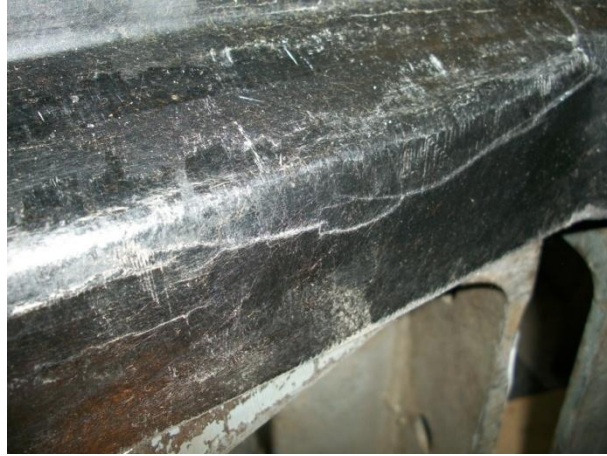
Photo.6

The frame showed a little damage with some light cracks on the edge. (Photo.6)
