TEST REPORT

FM45-D400-160 Trench Panel EN124 D400 Test

Date: 10/04/13

Client: Fibrelite Composites Ltd.

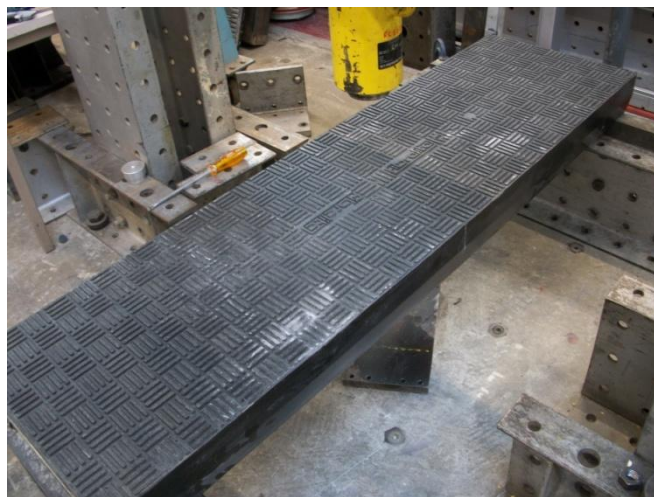
Photo. 1

The cover supplied is a rectangular FM45, 1600mm x 450mm x 120mm Trench panel and of composite construction. (See photo. 1)

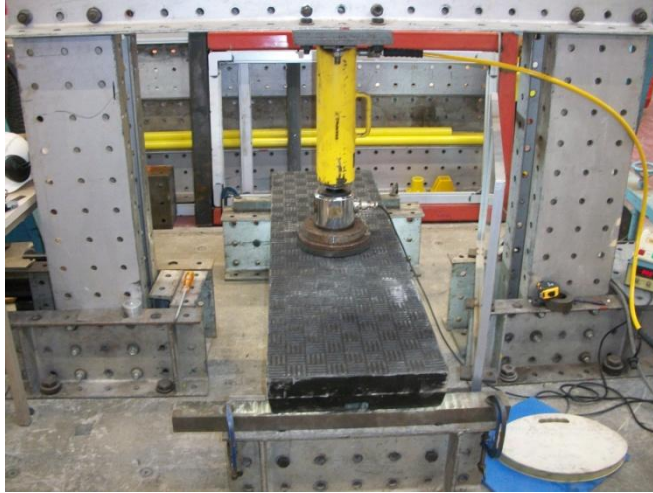
Photo. 2

The test rig consists of a 'giant mecano' frame bolted to the floor and supporting the Enerpac 50 tonne hydraulic cylinder. (Photo 2)

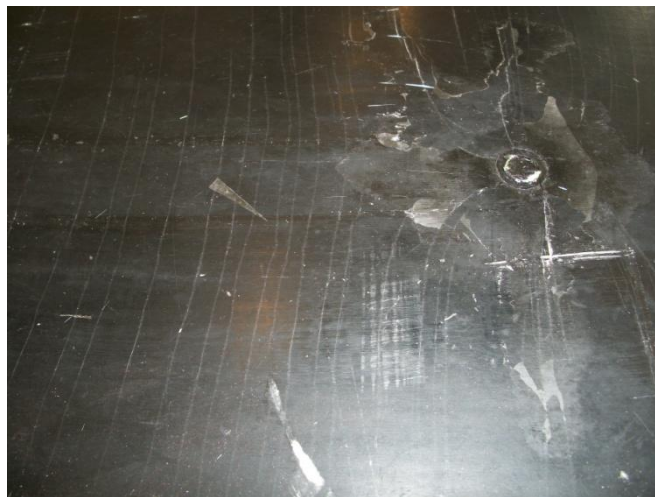
Photo.3

The only visible sign of damage was on the underside where some light cracks could be seen near the centre. (Photo.3)
