TEST REPORT

FL140 EN124 D400 Test

Client: Fibrelite Composites Ltd.

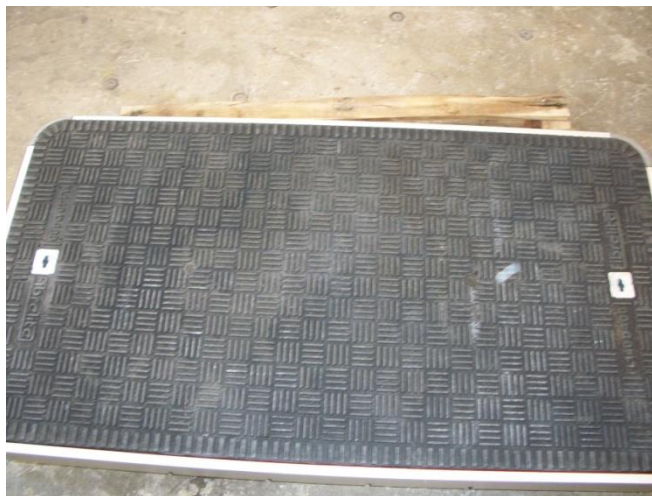
Photo. 1

The cover supplied is a rectangular FL140 and of composite construction. (See photo. 1)

The cover sat in an aluminium frame, complete with seal and has a clear opening of 1400mm x 700mm.

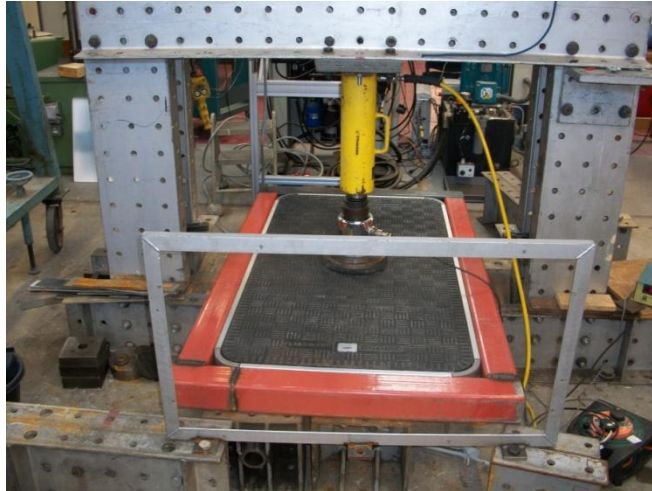
Photo. 2

The test rig consists of a 'giant mecano' frame bolted to the floor and supporting the Enerpac 50 tonne hydraulic cylinder. (Photo 2)

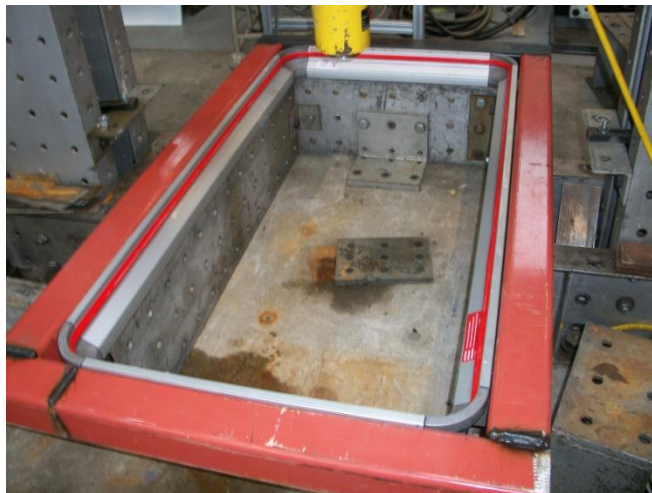
Photo.3

The cover and frame were sat on steel channels and plates with steel shims to pack and level. The frame also sat in a steel framework made of 100mm x 100mm steel box section; this was to give support to the aluminium frame and for safety during testing. (Photo.3)

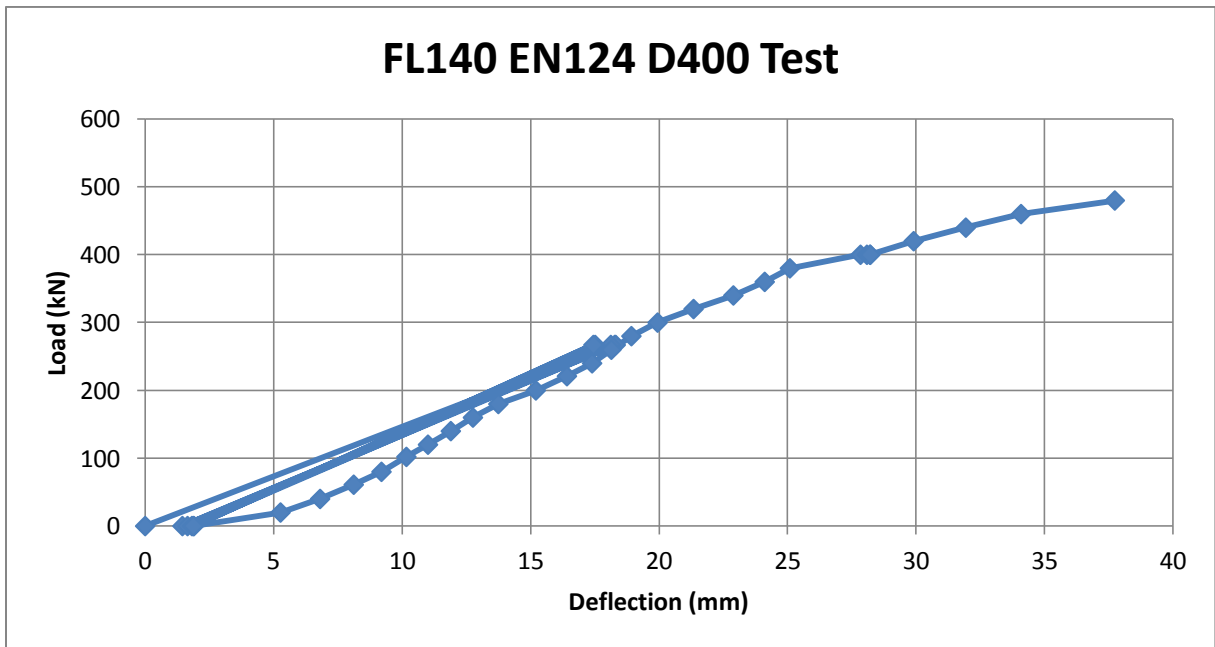
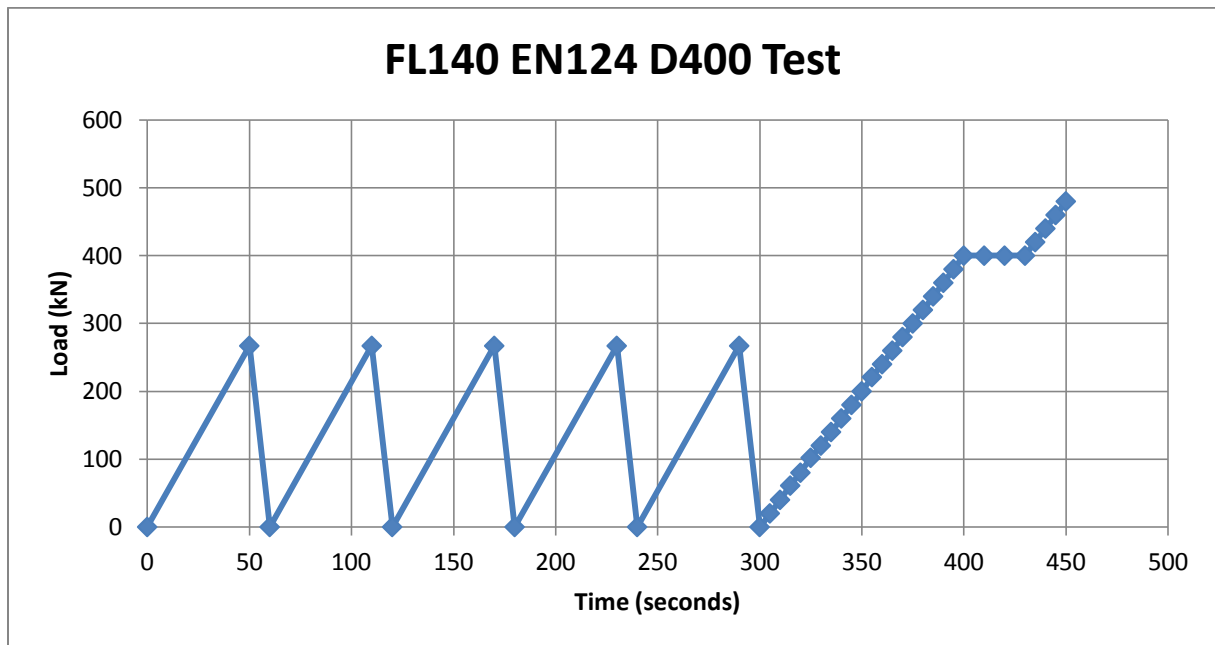
Load (kN)	Deflection (mm)	Remarks
0	0.00	
267	18.28	Light cracking noises from 40kN onwards for the 1 st cycle.
0	1.45	
267	18.32	
0	1.65	
267	18.13	
0	1.82	
267	17.52	
0	1.90	
267	17.45	
0	1.87	
20	5.27	
40	6.81	
61	8.12	
80	9.20	
102	10.17	
120	11.01

140	11.90	
160	12.76	
180	13.75	
200	15.21	
221	16.42	
240	17.40	
260	18.15	
280	18.93	
300	19.95	
320	21.35	
340	22.90	
360	24.12	
380	25.10	
400	27.85	
400 (10 seconds)	28.10	
400 (20 seconds)	28.22	
400 (30 seconds)	28.23	
420	29.92	
440	31.95	
460	34.10	
480	37.75	Max. load reached of test rig. Cover did not fail!

In accordance with EN124 Clause 8.3.1 the permanent set of the cover was 1.87mm which is within the permissible stated in Table 8 of the standard. ($1/300 \times 700 = 2.33\text{mm}$).

The cover therefore passed the EN124 D400 test for both permanent set and load.

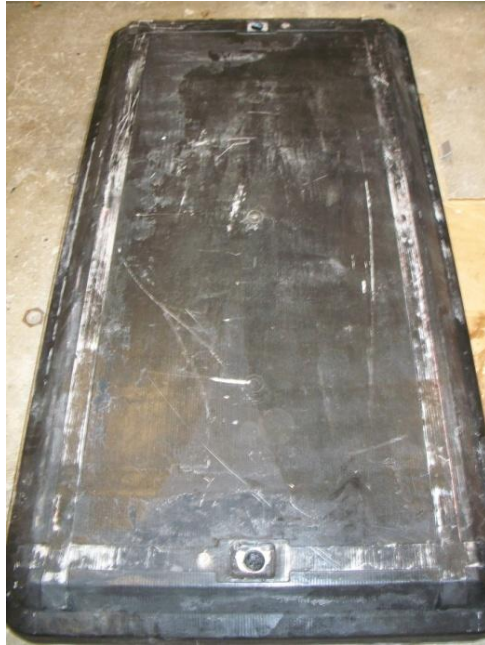
Photo.4

Photograph 4 shows the underside of the cover after it had been removed from the test rig. There were no signs of any cracking.
