## **TEST REPORT**

### **FM45-D400-1350 Trench Panel EN124 D400 Test**

**Client: Fibrelite Composites Ltd.**

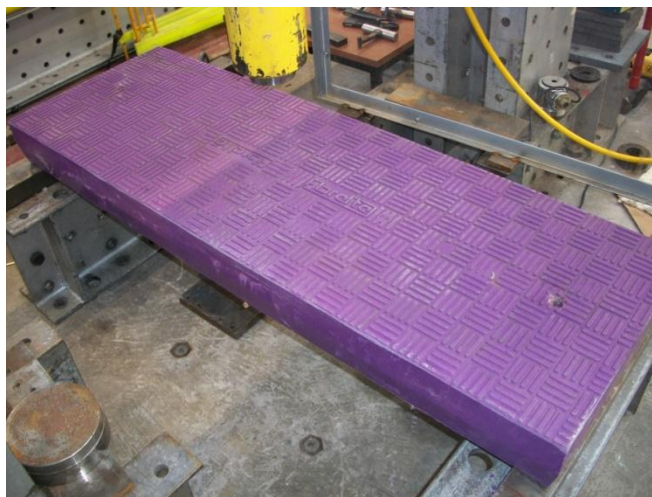
Photo. 1

The cover supplied is a rectangular FM45, 1350mm x 450mm x 120mm Trench panel and of composite construction. (See photo. 1)

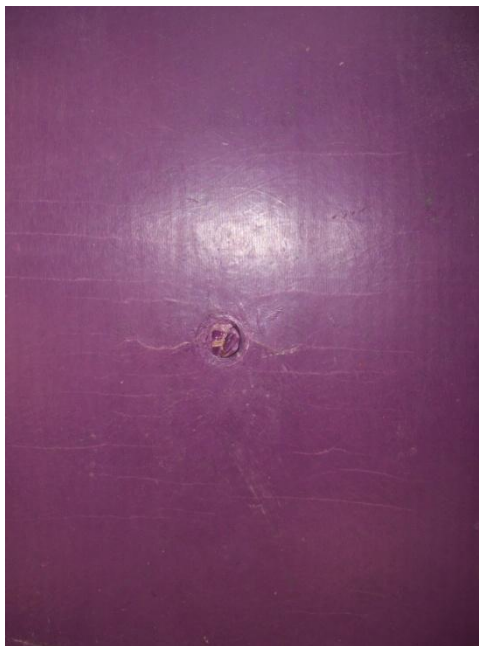
Photo.3

The only visible sign of damage was on the underside where some light cracks could be seen near the centre. (Photo.3)

Unfortunately the test had to be stopped at 480kN when the capacity of the test rig had been reached and the panel had not actually failed.
