# TEST REPORT

## FL450 Composite Cover BS EN124 C250 Test

Document reference number - FIB-FL450-C250-21-12-16

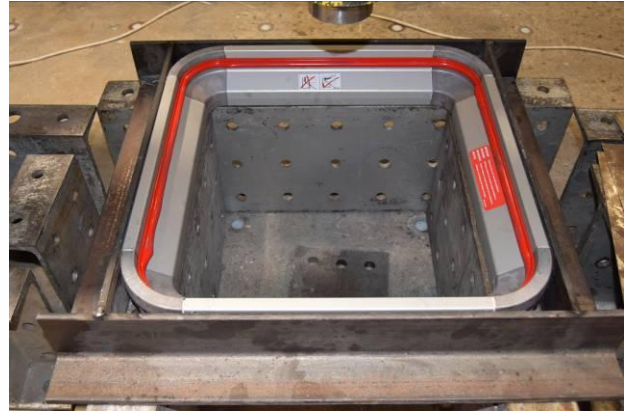
Photo.2

The test rig consists of a 'giant mecano' frame bolted to the floor and supporting the Enerpac 50 ton hydraulic cylinder.

The cover was seated on steel channels with steel shims to pack and level.

A steel frame made from 100mm x 75mm x 10mm steel angle was placed round the frame to act as a support. (Photo.2)

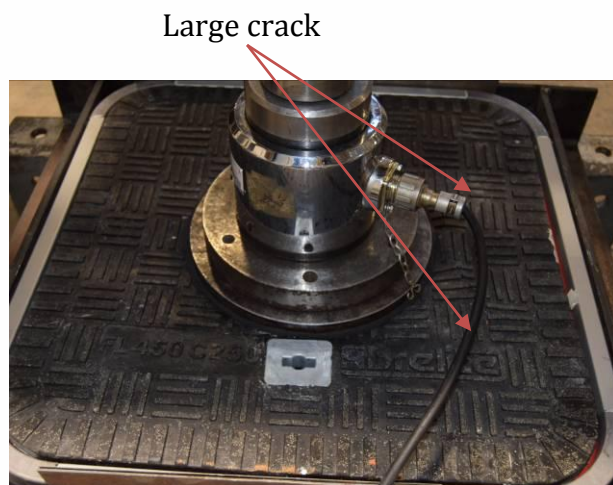
Photo.5

The cover was then loaded further until ultimate failure occurred at 340kN.

Photograph 5 below shows the cover still in the test rig at failure and the top face badly deformed around the loading pad area with one large crack on the top face.
