# TEST REPORT

## FL60 Composite Cover BS EN124 A15 Test

Document reference number - FIB-FL60-A15-20-12-16

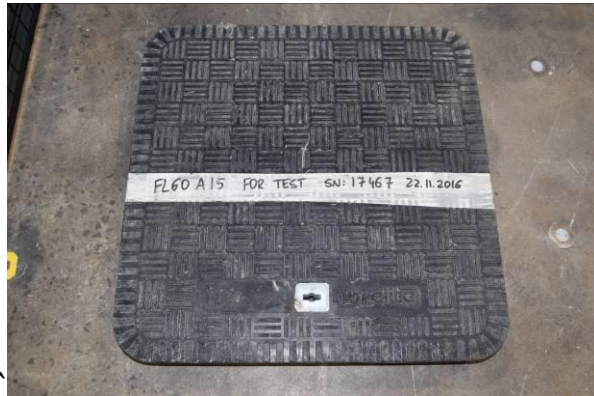
Photo. 1

The composite cover supplied is a square FL60 complete with aluminium frame. (Photo.1)

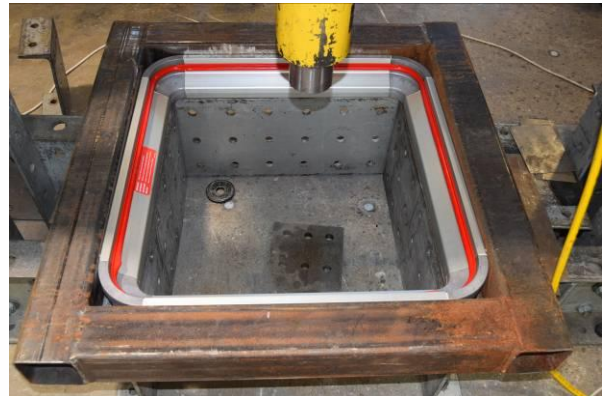
Photo.2

A steel frame made from 100mm x 100mm steel box section was placed round the frame to act as a support. (Photo.2)

The cover was seated on steel channels with steel shims to pack and level.

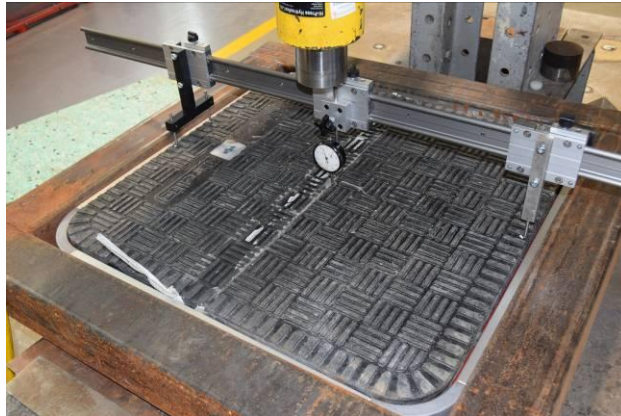
Photo.4

Photograph 4 below shows the initial reading being taken for the permanent set test.

Initial Reading	0.00mm
Reading after 5 cycles	0.15mm
<b>Permanent Set</b>	<b>0.15mm</b>

Permissible permanent set for an A15 test is  $\frac{CO}{100} = \frac{600}{100} = 6.00\text{mm}$

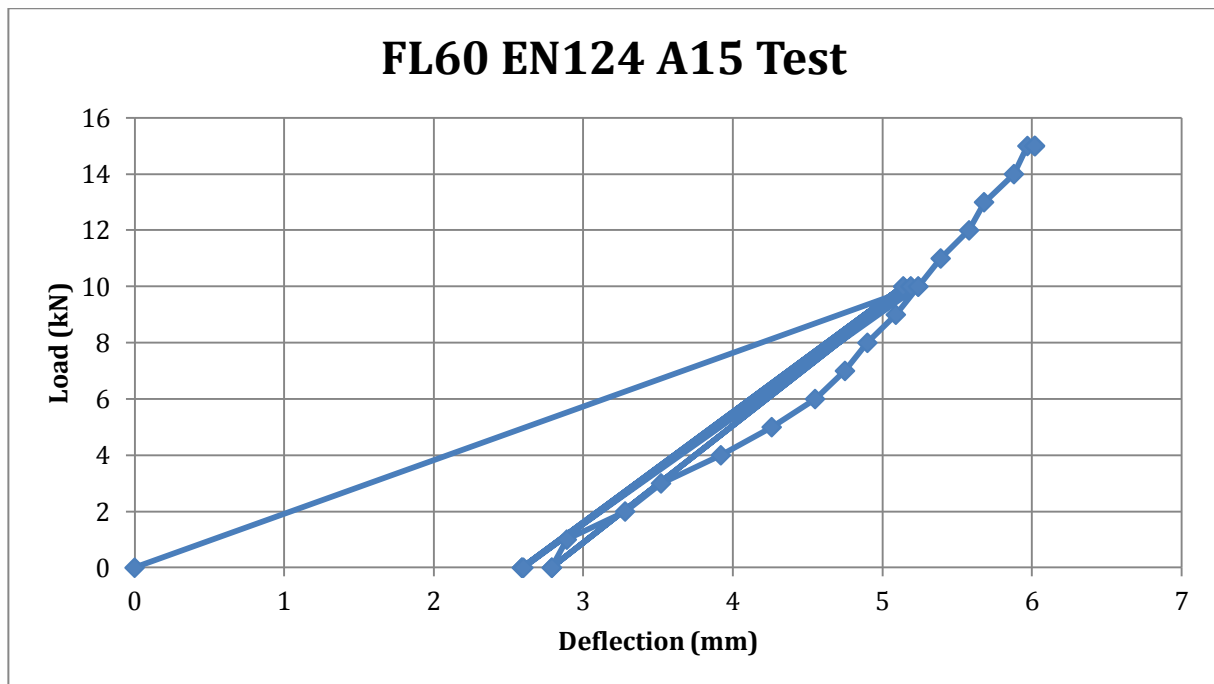
Graph above shows a large initial deflection which was caused by the cover not being fully seated before the first load cycle was applied.

Although the standard does not require it for the load bearing test, a measuring device (linear potentiometer) was placed on the underside of the panel directly under the loading point and deflection readings taken every 10kN for the five cycles and 1kN intervals after that.

LOAD (kN)	DEFLECTION (mm)	REMARKS
0	0.00	
10	5.24	Large initial deflection as cover had not seated fully in frame before load was applied.
0	2.59	
10	5.14	
0	2.59	
10	5.14	
0	2.60	
10	5.19	
0	2.79	
10	5.19	
0	2.79	
1	2.89	
2	3.28	
3	3.52	
4	3.92	
5	4.26	
6	4.55	
7	4.75	
8	4.90	
9	5.09	
10	5.24	
11	5.39	
12	5.58	
13	5.68	
14	5.88	
15	5.97	
15 (10 seconds)	6.02	<b>PASS</b>
15 (20 seconds)	6.02	
15 (30 seconds)	6.02	
0	3.05	
86.4	Gauge removed	Ultimate failure

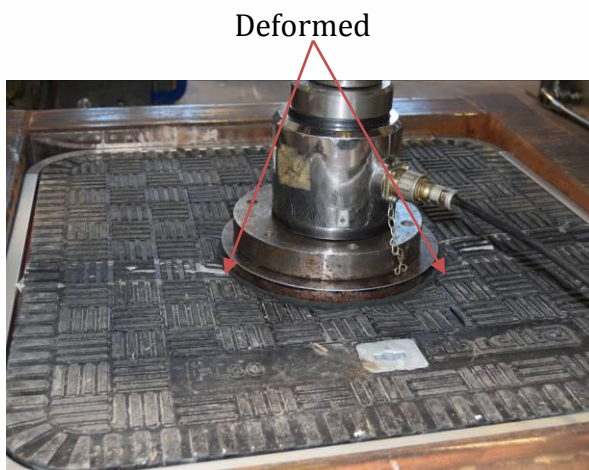
Photo.5

Photograph 5 below shows the cover still in the test rig at failure and the top face badly deformed around the loading pad area.

A larger capacity 1000kN load cell (SN. 3243N) replaced the 50kN one and the cover loaded further until ultimate failure occurred at 86.4kN.

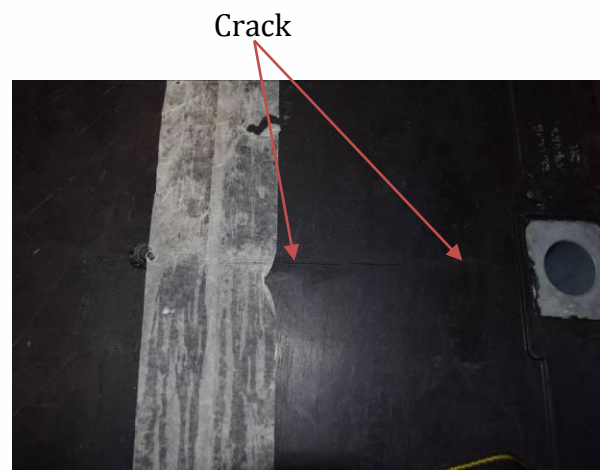
Photo.6

On removal from the test rig the underside had a large crack running through the centre of the cover. (Photo.6)
