TEST REPORT

FL45 COVER TEST

Client : Fibrelite Composites Ltd.

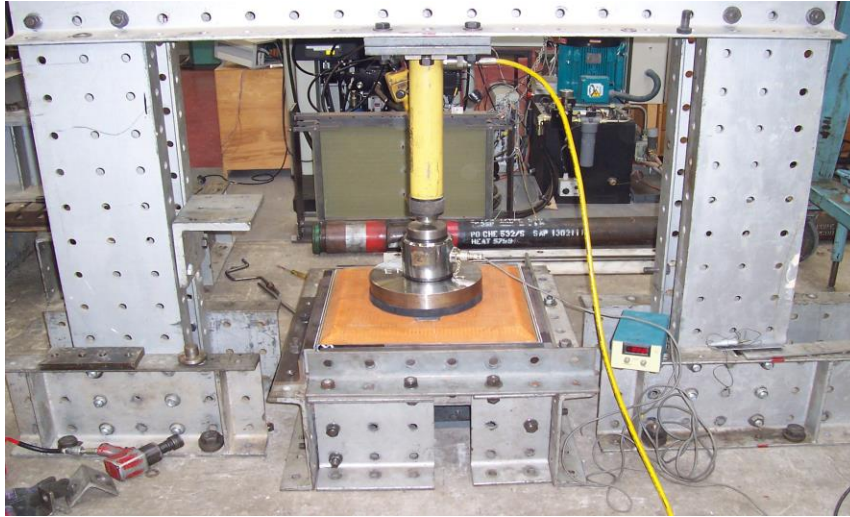
Photo. 2

The test rig consists of a 'giant mecano' frame bolted to the floor and supporting the Enerpac 50 tonne hydraulic cylinder. (Photo 2)

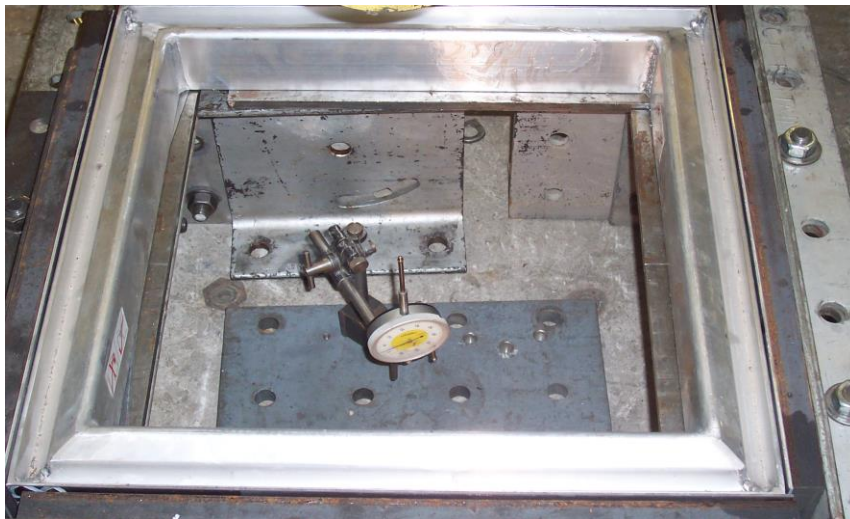
Photo.3

The cover and frame were sat on steel channels with steel angle to support the sides of the frame to stop any distortion. Steel and aluminium shims were used to pack and level up. (Photo. 3)

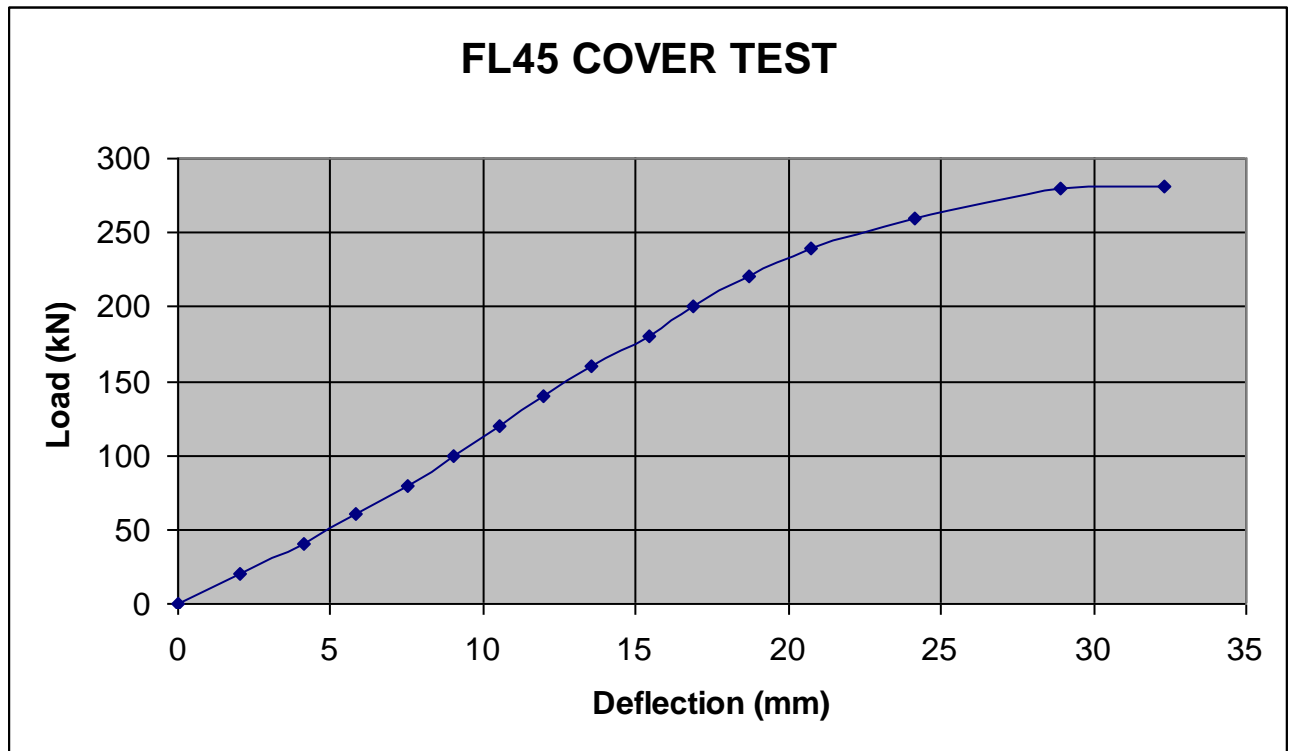
LOAD (kN)	DEFLECTION (mm)	REMARKS
0	0	
20	2.00	
40	4.14	
60	5.85	
80	7.53	
100	9.00	Light cracking noises
120	10.51	
140	11.96	
160	13.55	
180	15.42	
200	16.86	
220	18.73	
240	20.72	Louder cracking
260	24.12	
280	28.90	
281	32.30	Loud bang (failure)

The cover failed at 281kN. A loud bang was heard and the load could not be maintained.
