TEST REPORT

FL600 EN124 B125 Cover Test Test 2

Date: 13/03/12

Client: Fibrelite Composites Ltd.

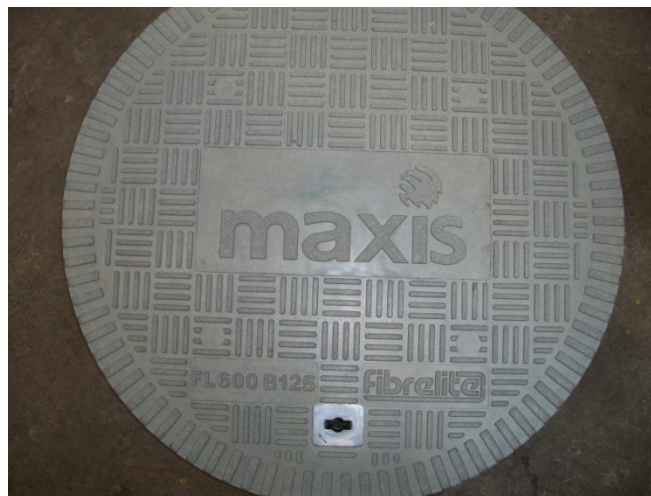
Photo.1

The cover supplied is a Fibrelite FL600. (Photo.1)
Cover No. – 3233

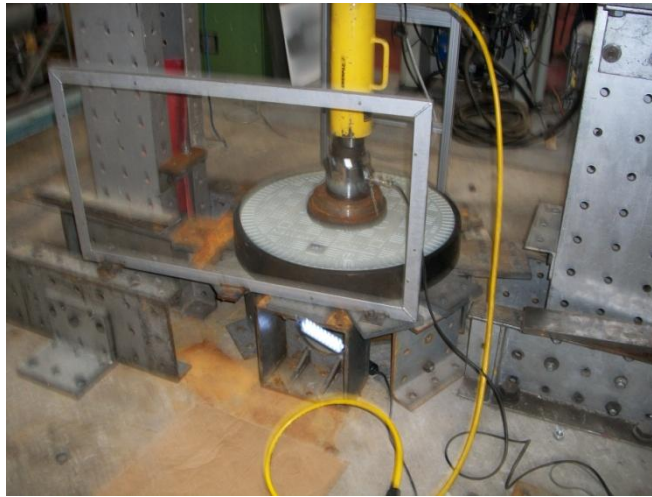
Photo.2

The test rig consists of a 'giant mecano' frame bolted to the floor and supporting the Enerpac 50 tonne hydraulic cylinder. (Photo 2)
