TEST REPORT

FL900 EN124 C250 Cover Test

Date: 21/01/10

Client: Fibrelite Composites Ltd.

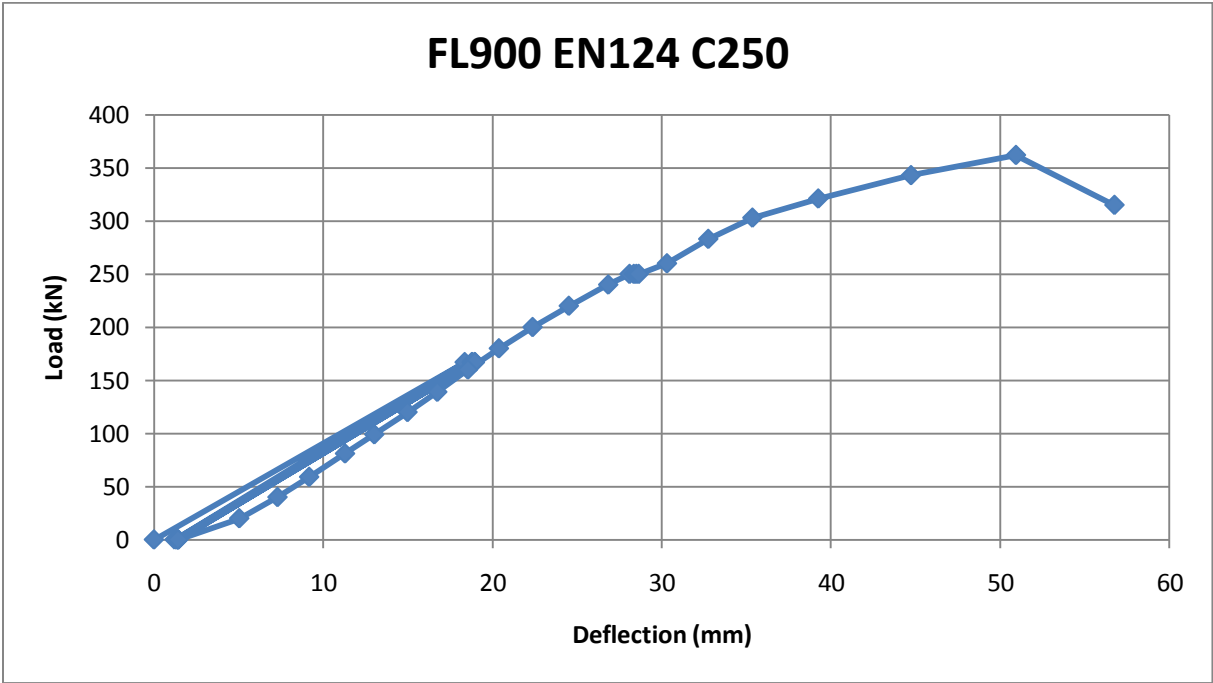
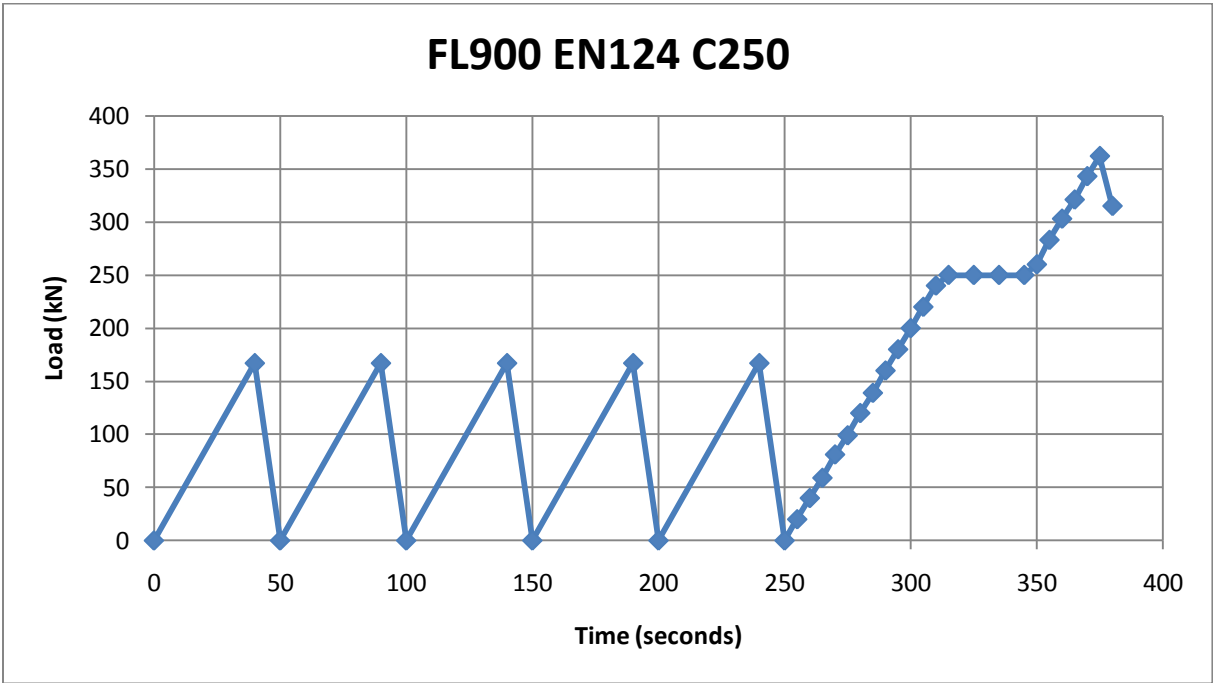
In accordance with EN124 Clause 8.3.1 the permanent set of the cover was 1.42mm which is within the permissible stated in the standard ($1/300 \times 900 = 3.00\text{mm}$) The cover therefore passed that test.

The cover held the required test load of 250kN for 30 seconds and therefore passed the test.
