## **TEST REPORT**

### **FL900 EN124 E600 Cover Test**

Date: 16/04/13

**Client: Fibrelite Composites Ltd.**

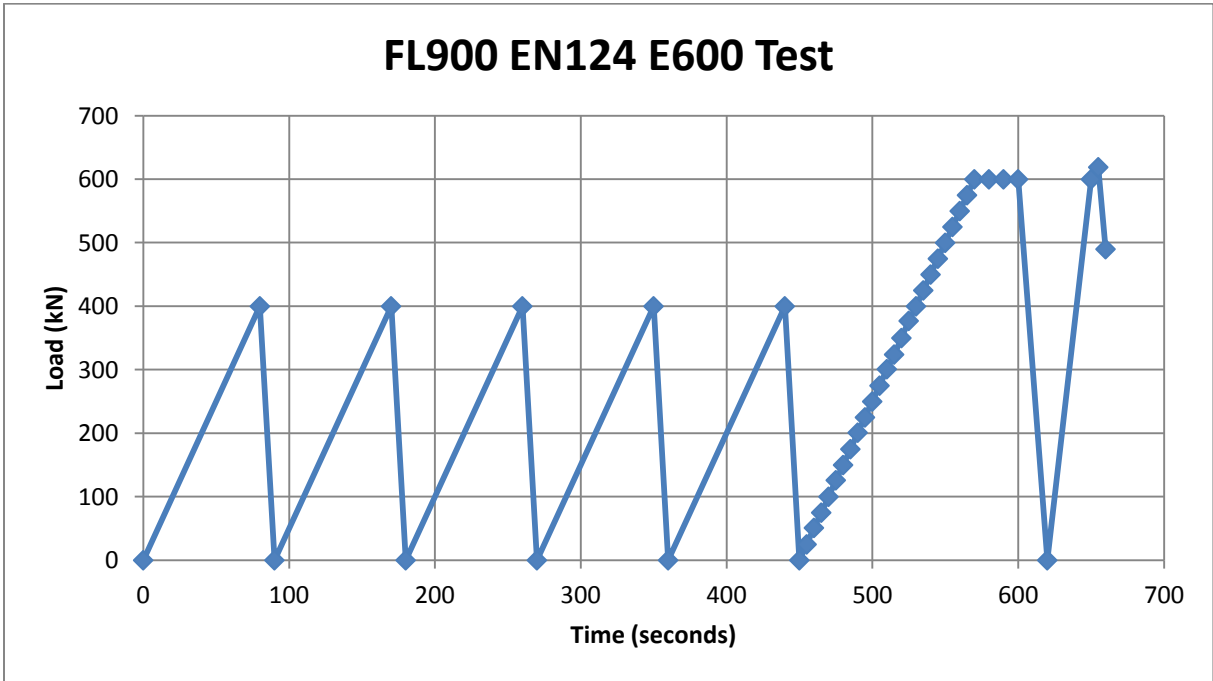
**FL900 EN124 E600 Test**

**The cover held the test load of 600kN for the required 30 seconds so therefore passed the EN124 E600 test.**

**In accordance with EN124 Clause 8.3.1 the permanent set of the cover was 2.78mm which is within the permissible stated in Table 8 of the standard. ( $1/300 \times 900 = 3.00\text{mm}$ ).**
