TEST REPORT

FL90/CF/D400 Cover Test

Client: Fibrelite Composites Ltd.

Date: 07/04/06

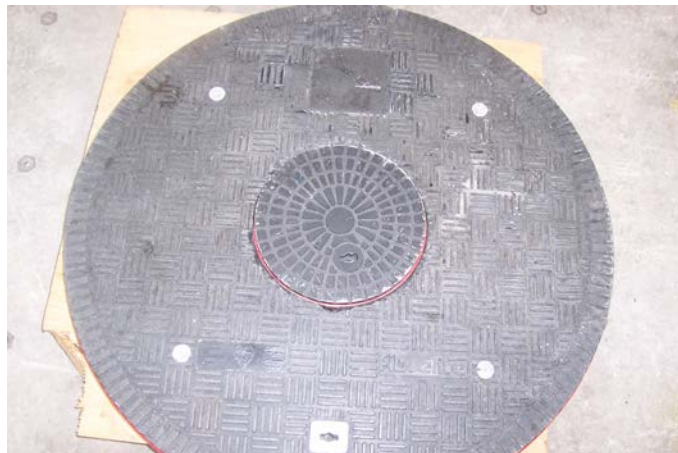
Photo.1

The cover supplied is an FL90/CF/D400 and of composite construction. It has one access hole with a cast aluminium lid 300mm in diameter. A red sealing ring is on both the cover and aluminium lid.

No. on edge of cover – 06 1829 90 D/S

The cover was seated in a previously tested frame.
The serial no. on the frame is 11380, Model FL90

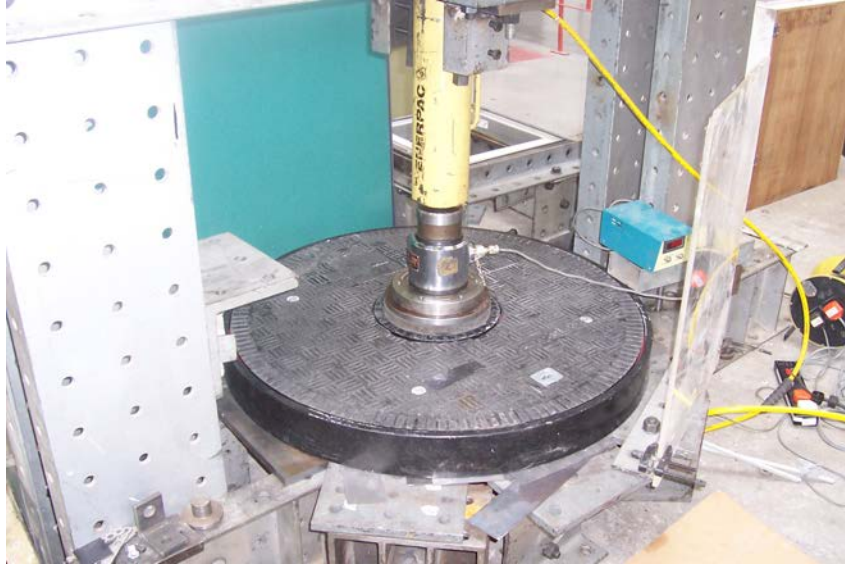
Photo. 2

The test rig consists of a 'giant mecano' frame bolted to the floor and supporting the Enerpac 50 tonne hydraulic cylinder. (Photo 2)

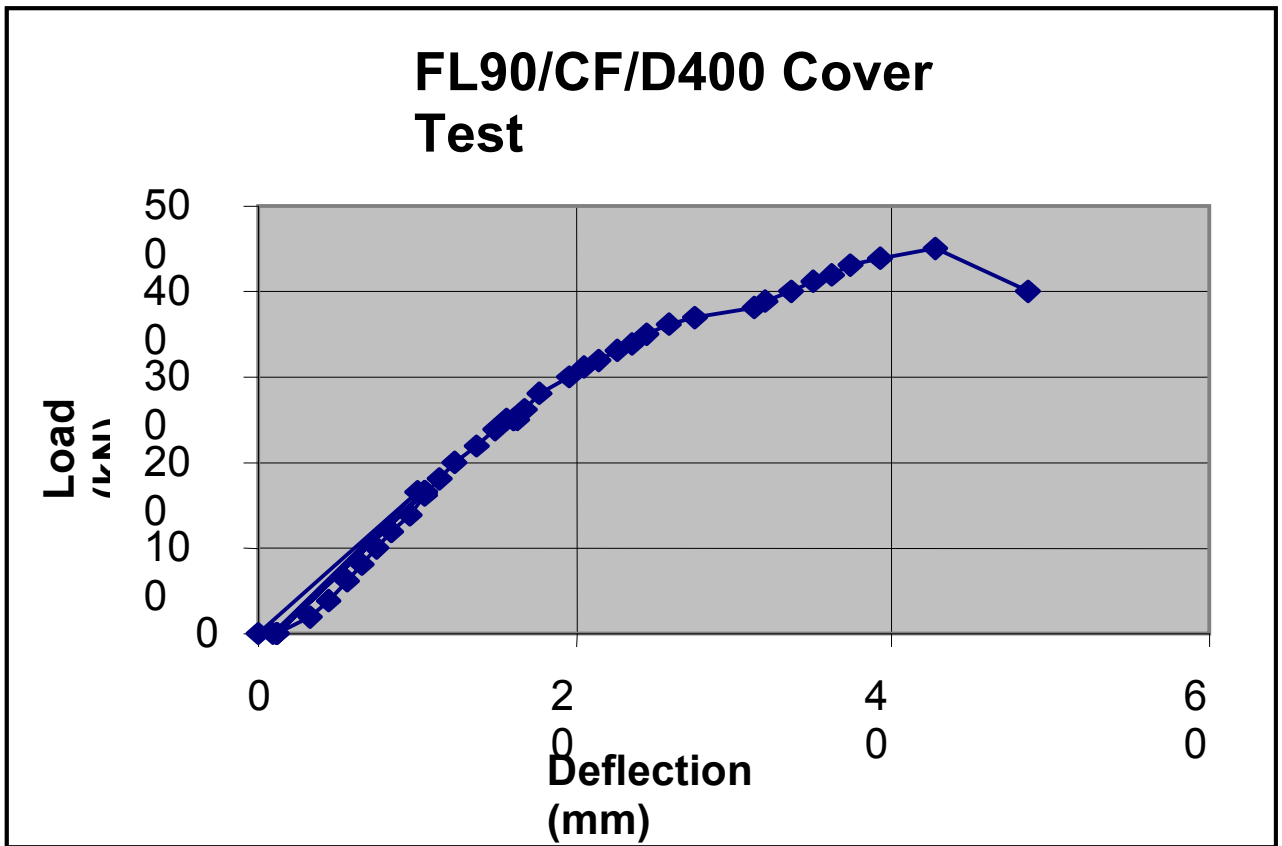
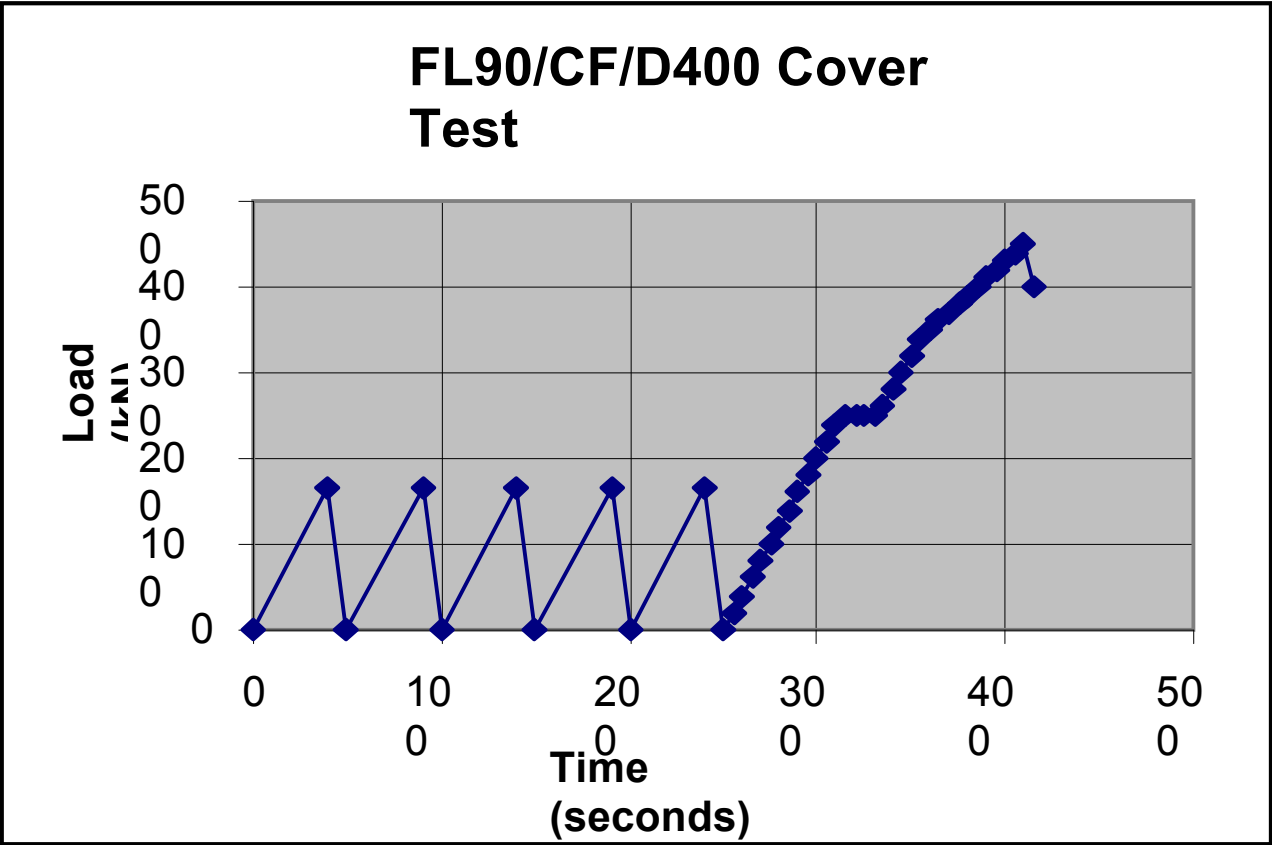
In accordance with EN124 Clause 8.3.1 the permanent set of the cover was 1.25mm which is within the permissible stated in Table 8 of the standard. ($1/300 \times 900 = 3.0\text{mm}$).

The cover also held the test load with no visible signs of cracks.

After the initial test load was achieved the cover was loaded further and at 445kN the cover failed.

On inspection two cracks had appeared on the top surface and the frame had bulged out slightly leaving a gap between cover and frame. (See photo.3)
