TEST REPORT

FL90 Cover Test

Date: 28/05/10

Client: Fibrelite Composites Ltd.

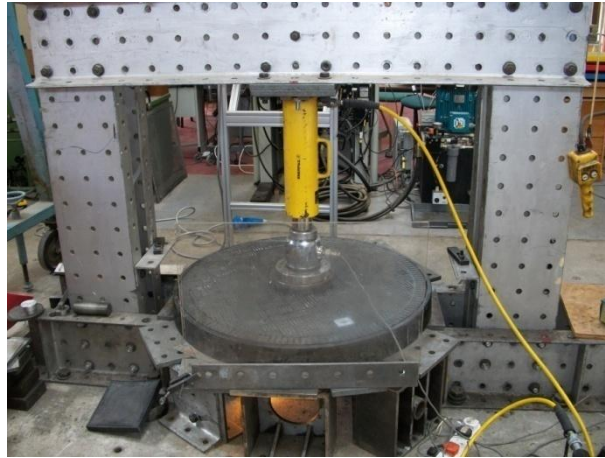
Photo. 2

The test rig consists of a 'giant mecano' frame bolted to the floor and supporting the Enerpac 50 tonne hydraulic cylinder. (Photo 2)
