TEST REPORT

FM45-D400-160 Trench Panel EN124 D400 Test

Date: 10/04/13

Client: Fibrelite Composites Ltd.

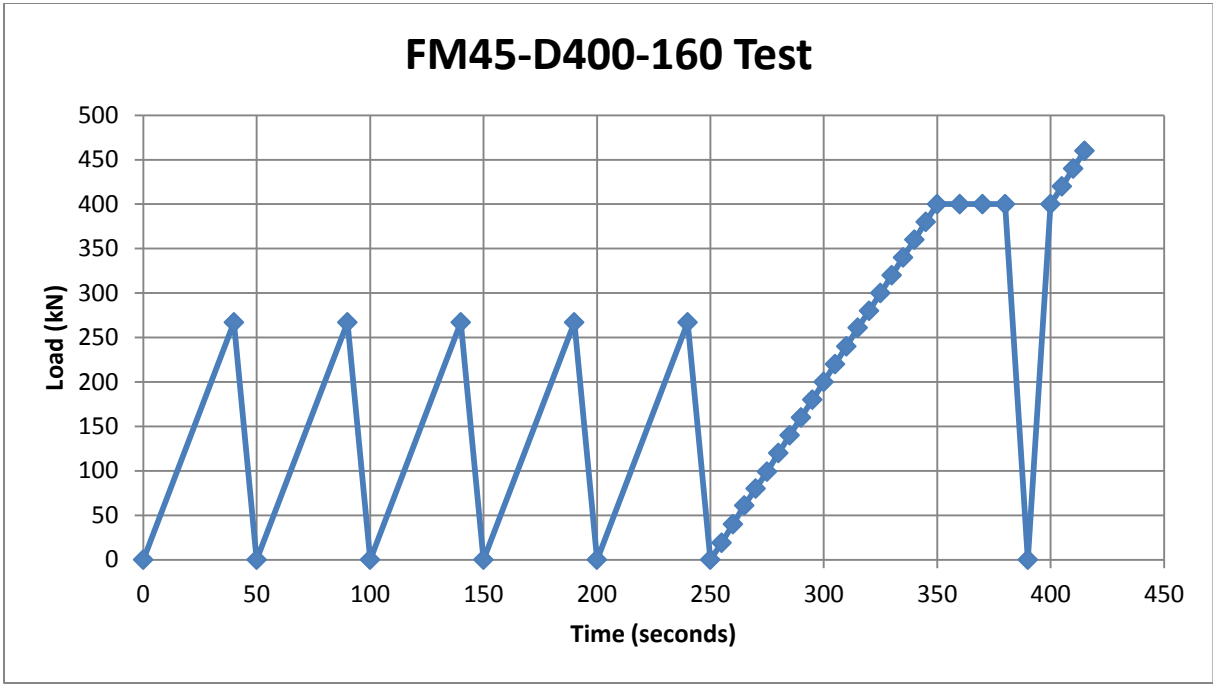
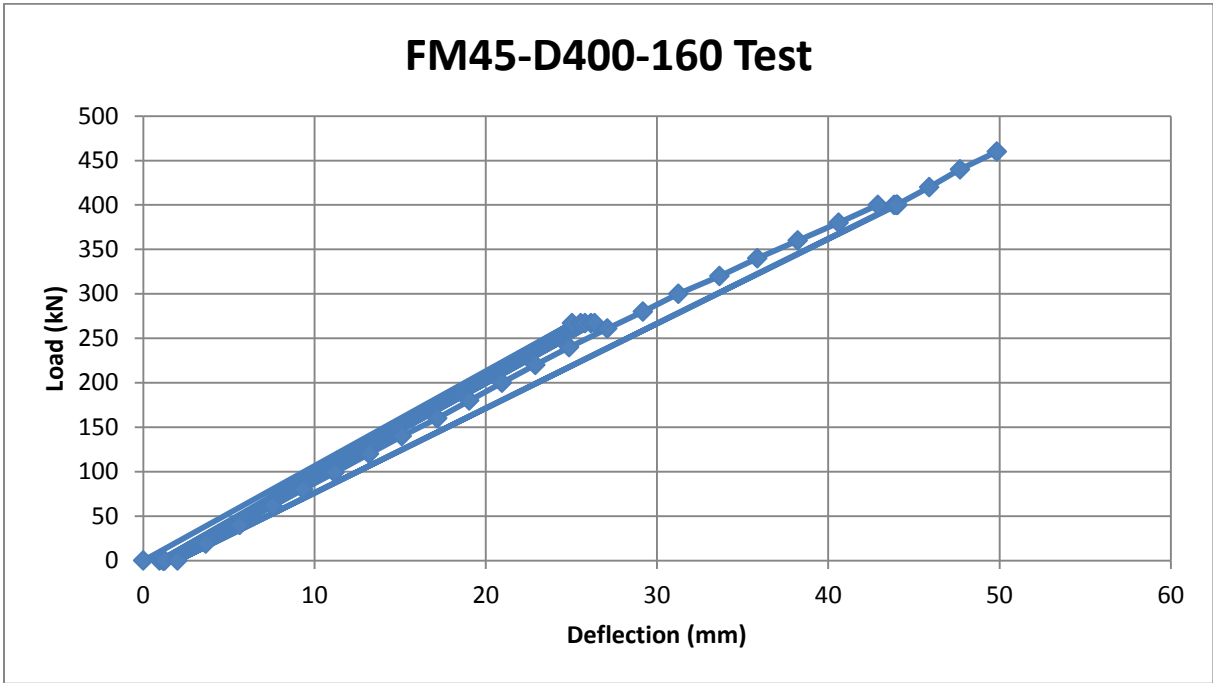
In accordance with EN124 Clause 8.3.1 the permanent set of the panel was 1.25mm which is within the permissible stated in Table 8 of the standard. ($1/300 \times 450 = 1.50\text{mm}$).

The panel held the test load of 400kN for the required 30 seconds.

The panel therefore passed the EN124 D400 test for both permanent set and load.

After the panel had passed the EN124 test the load was released from the 400kN and a permanent set of 2.00mm was recorded.

Unfortunately the test had to be stopped at 460kN when the capacity of the test rig had been reached and the panel had not actually failed.

The only visible sign of damage was on the underside where some light cracks could be seen near the centre. (Photo.3)
